The Hoof Redevelopment Center

A Division of Horses In Symmetry Farrier Services

Martin D. Kenny C.J.F. R.J.F.

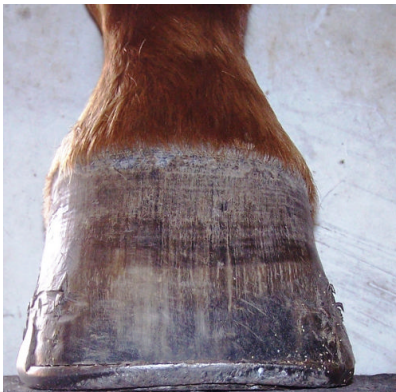
Plate #1

Both photos taken pre-shoeing

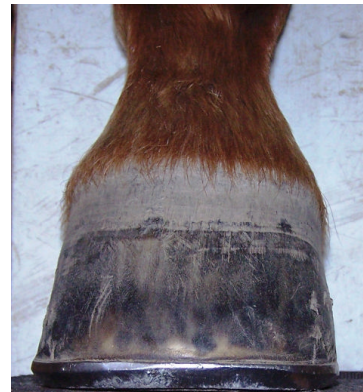
Notice that Plate #2 shows less bending (flaring) of walls than on Plate #1

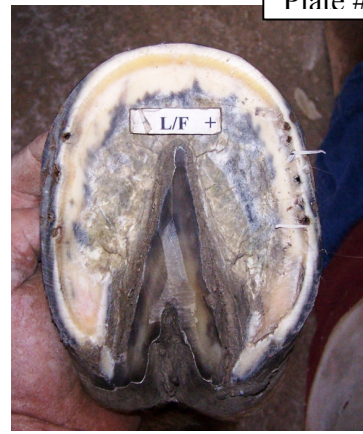
Note that Plate #4 shows less delamination of walls (blackened areas around perimeter of wall, sole junction, what has become known as "White Lines Disease") than on Plate #3. This is extremely important to health and comfort of the foot and the limb above.

Also note on the Plate #4 above, that the bar area to the right is becoming less bent and stands more upright than it was on Plate #3. The area from frog to wall is also more evenly distributed from left to right on Plate #4 than on Plate #3. These are all things that are extremely important to the strength of the hoof capsule. Making it able to properly absorb concussion in a balanced manner.

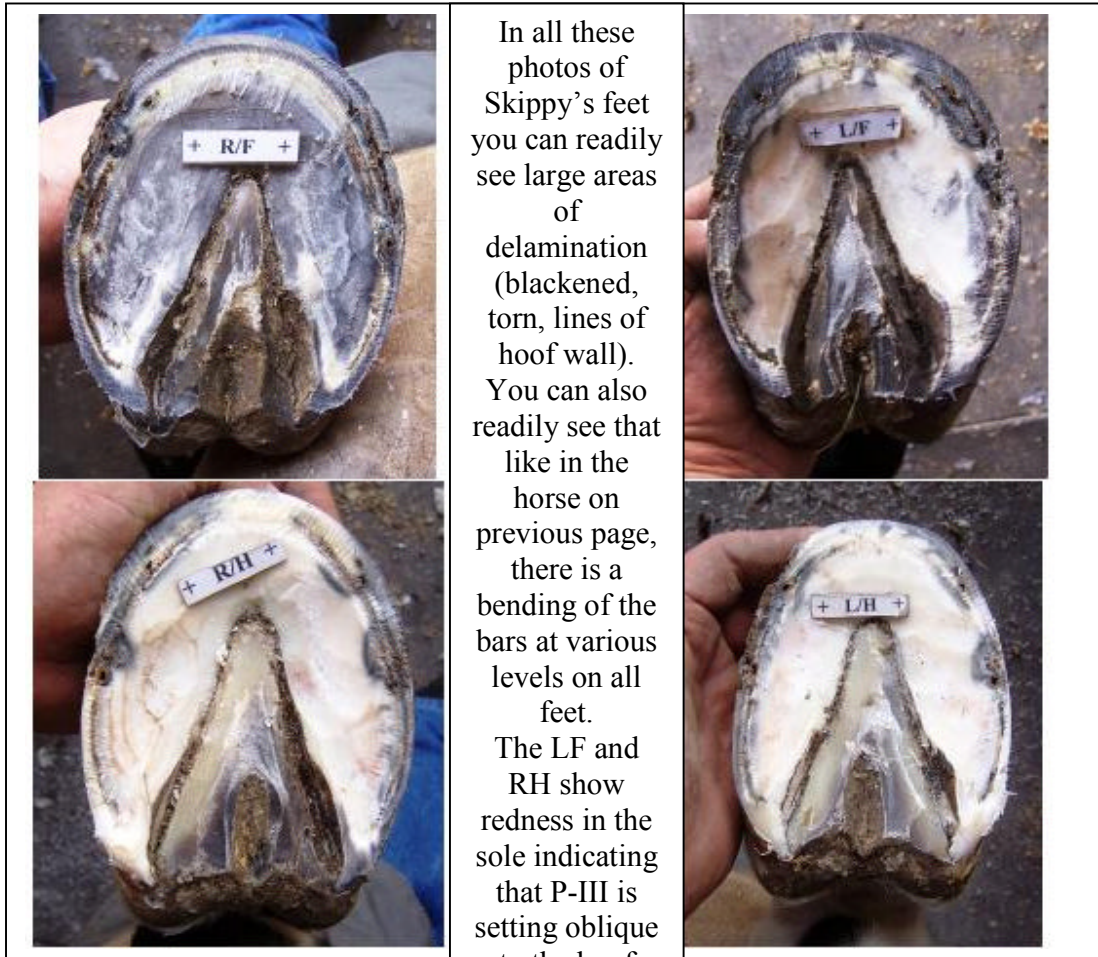
In all these photos of Skippy's feet you can readily see large areas of delamination (blackened, torn, lines of hoof wall). You can also readily see that like in the horse on previous page, there is a bending of the bars at various levels on all feet. The LF and RH show redness in the sole indicating that P-III is setting oblique to the hoof capsule and crushing against the sole in those areas.

If you look at the posterior (rear) portion of the frogs, you can see that the left and right portions are not the same. This further indicates that P-III is loading obliquely inside the hoof capsules.

If you look at RF and LF you will see that the frog appears to not point to the center of the hoof at toe. This indicates that the hoof capsule is rotating laterally (toward outside of limb) around P-III in an attempt to compensate for the Oblique loading of P-III
More so on RF than LF

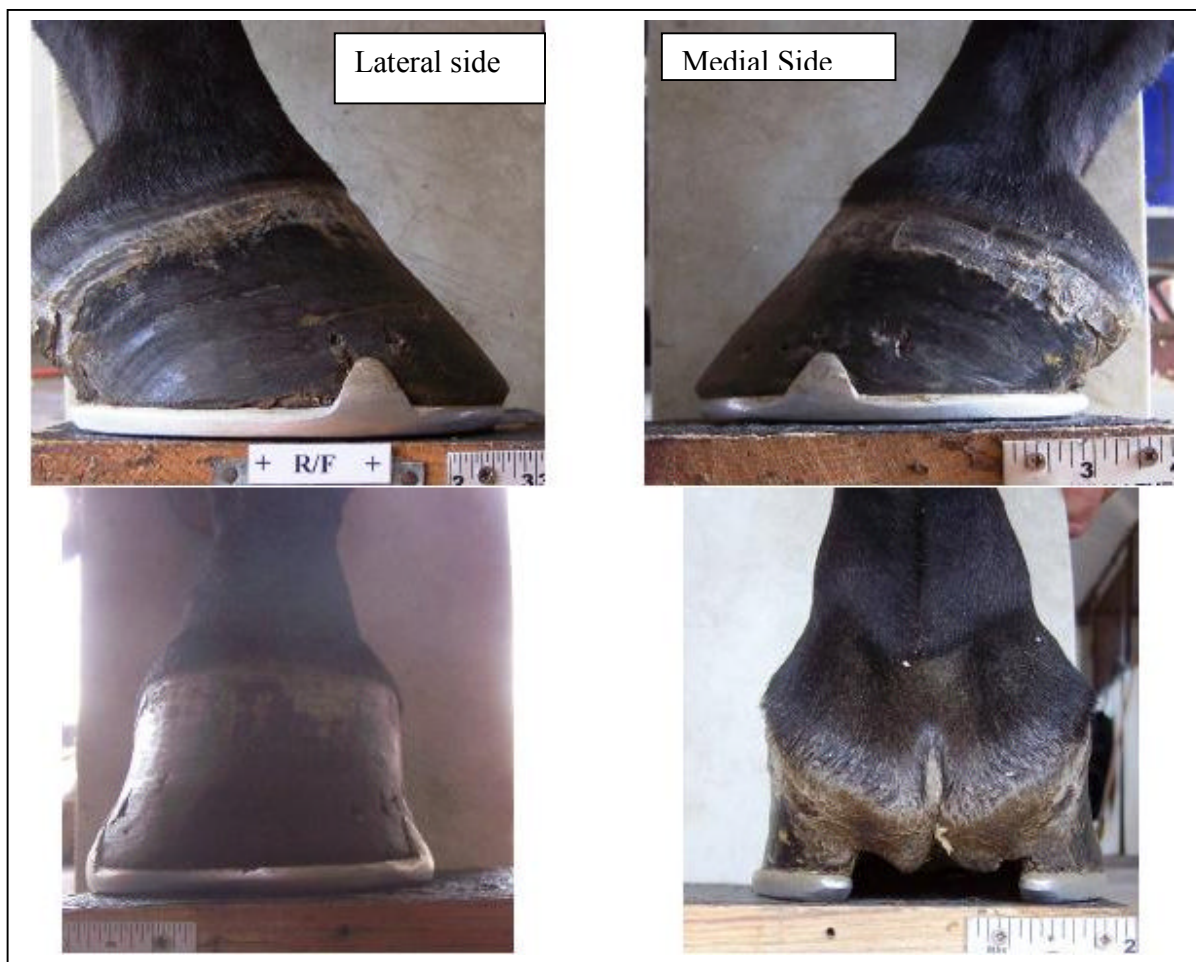
Skippy's Right Front foot shows considerable jamming of the hairline (wavy areas) and flaring of the toe region. If you study the two photos you will see that the two sides of foot do not match in the way they are distorting. This is only one more sign of the oblique loading of P-III

The flaking of the bottom of wall just behind the clip is the area of delamination that we saw on last set of photos. The ridges on walls show us further jamming of laminae and have created the delamination on that area that we saw on last set of photos.

The bottom photos show considerable bending (flaring) of the walls in the quarters of the hoof capsules. This flaring is a result of the delamination of the quarters of those regions. On the photo to the left above, you can see that the left (lateral wall) toe wall is flared worst than the medial (right wall) toe wall. This is how the foot adapts to the oblique loading of P-II by rotating laterally.

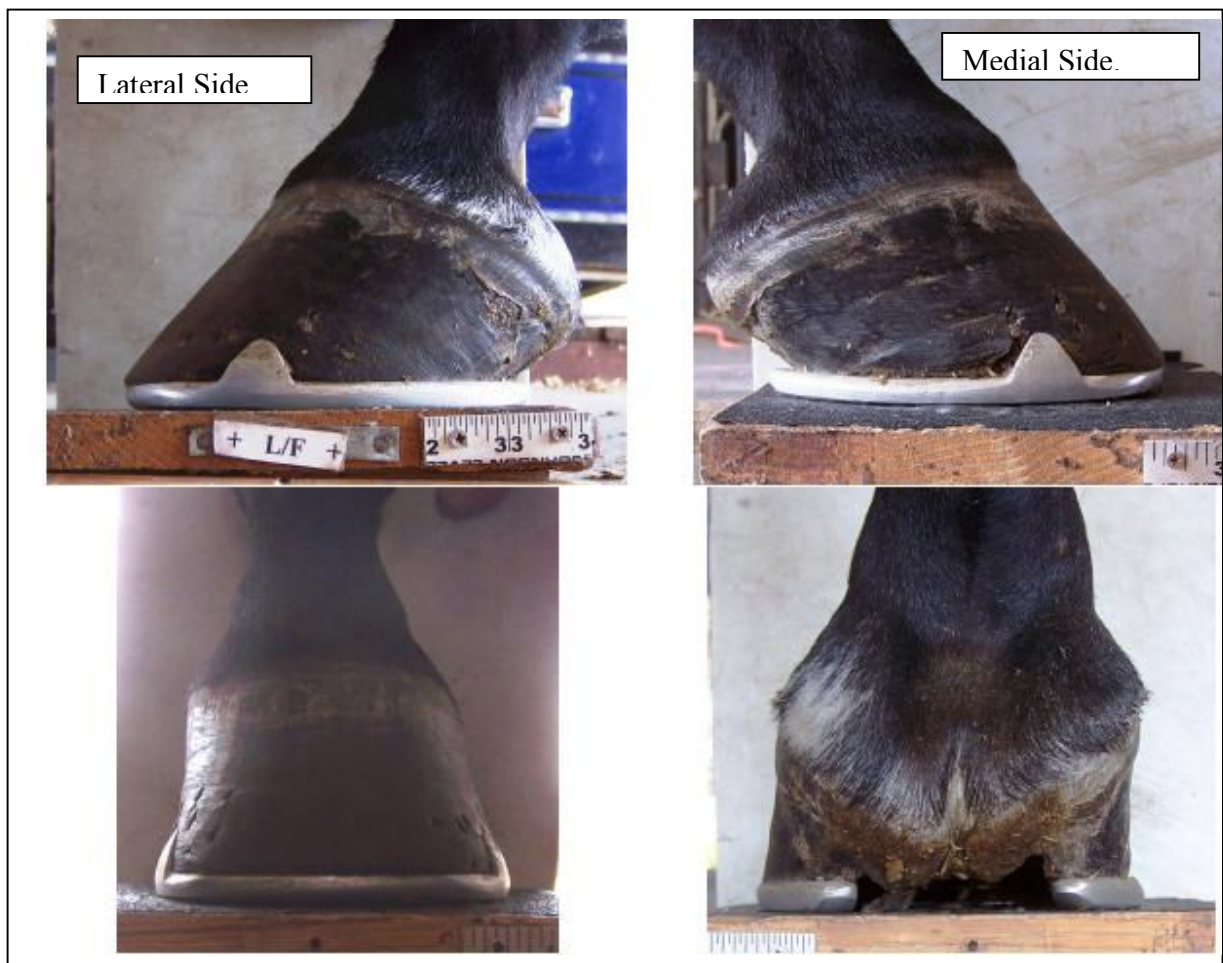
On the Left Front, we see many of the same concerns that we see on the Right Front (last set of photos)

Of interesting note here is that while the lateral side of the RF showed the most jamming (ridges) the LF shows the most jamming on the medial side. This would indicate that the horse is landing hard to the right as a protection mechanism; in order to find maximum comfort.

While we see much the same type of distortion (flaring) on this foot as we do on the RF, it is not as pronounced on this (LF) foot. Again showing that the horse is taking more load on right foot than left foot.
